**Work Order: MT-WO-5191
Customer PO: CC**

NON-Component Related Testing

The following is a summary of solderability tests performed for John Franey, of the Reliability Physics Group, Bell Labs, Lucent Technologies out of Whippany, NJ.

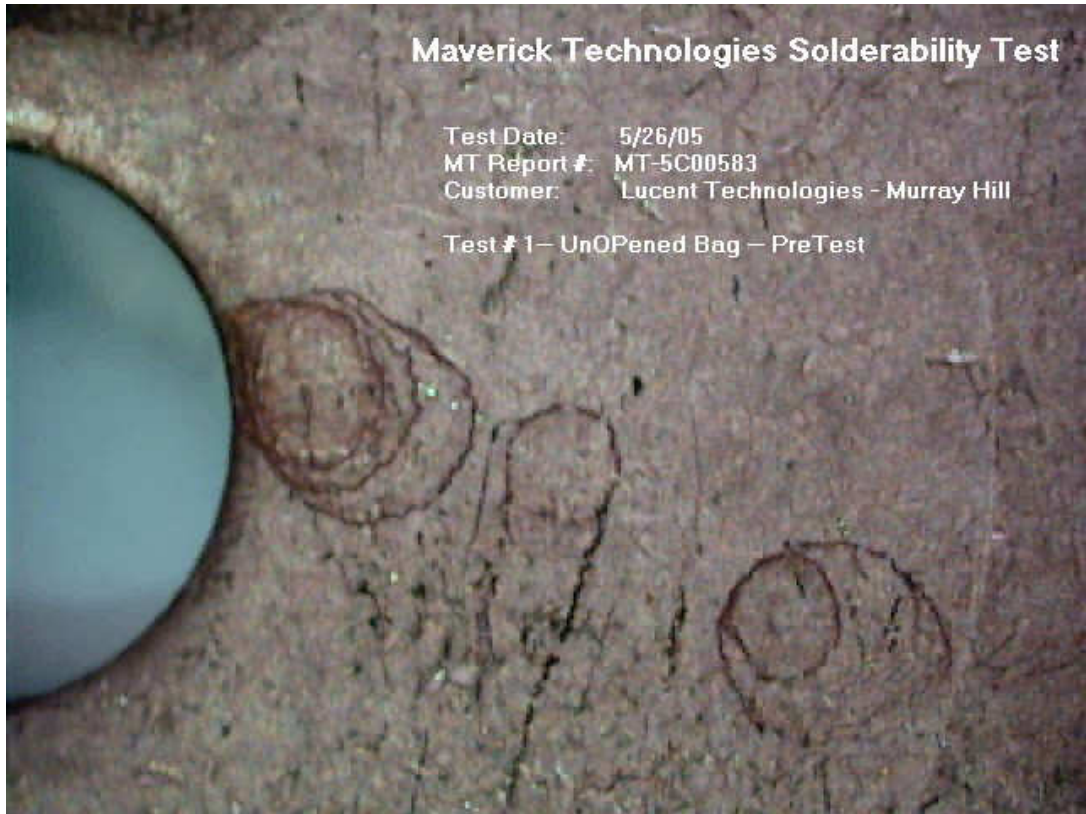
Sample 1

Samples 1 through 7 all had very similar appearances in oxidation levels. These were all reported to have been initially placed in the bags and sealed in 1988. Slight deviations seemed to occur from sample to sample, but in magnitude all had a similar level. Samples 1-4 were all in un-opened bags. Sample 5 was in a bag that had been torn at some point previous to our inspection. Samples 6 & 7 were in bags that were opened some 4 years previous, ~2001 time period. Sample 8 was the larger bus plate that was in a standard clear bag. Heavy oxidation was noted and observed on this sample.

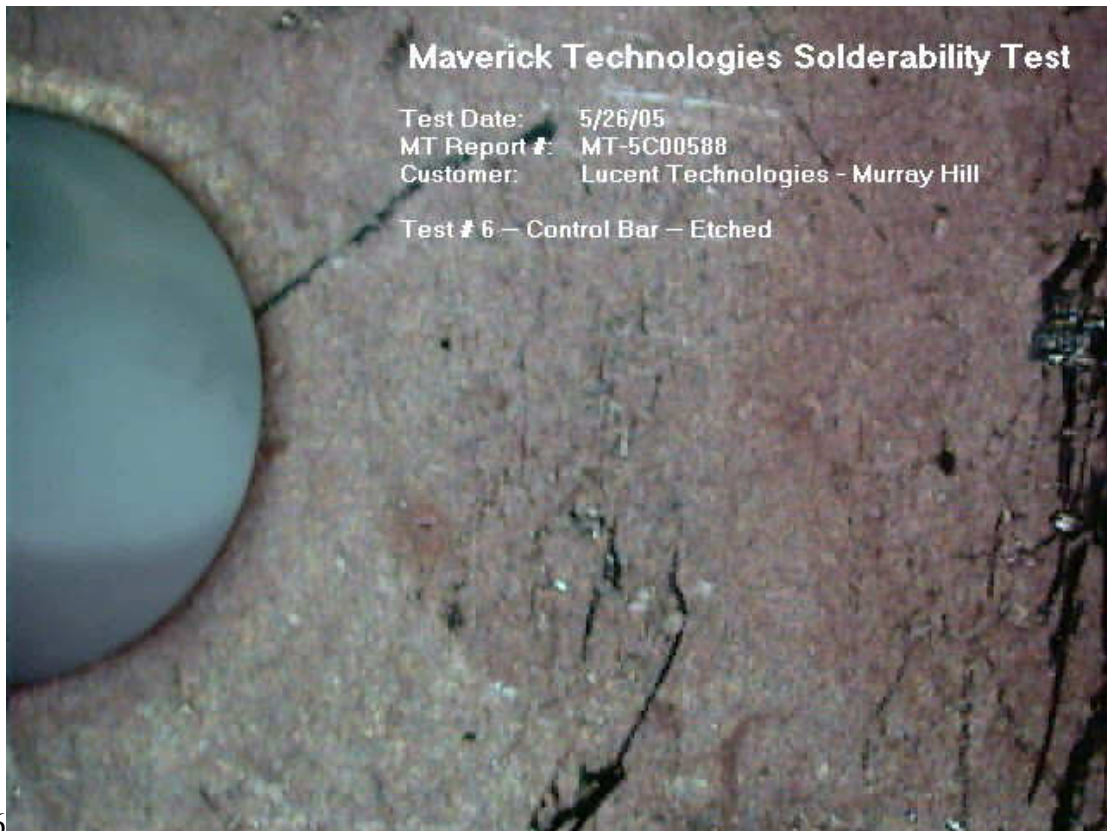
Sample 6 was etched with a light acid (acetic), to remove the any light oxidations that existed and would serve as the baseline control for comparing the levels of solderability. The following pics reflect those as received conditions, including Sample 6, after the etch process. Due to the size of each bus bar, only a portion of each was photographed, which correlates to the areas that were solder dipped. Due to the extreme large size of sample 8, we took a conventional photo of it for reference.

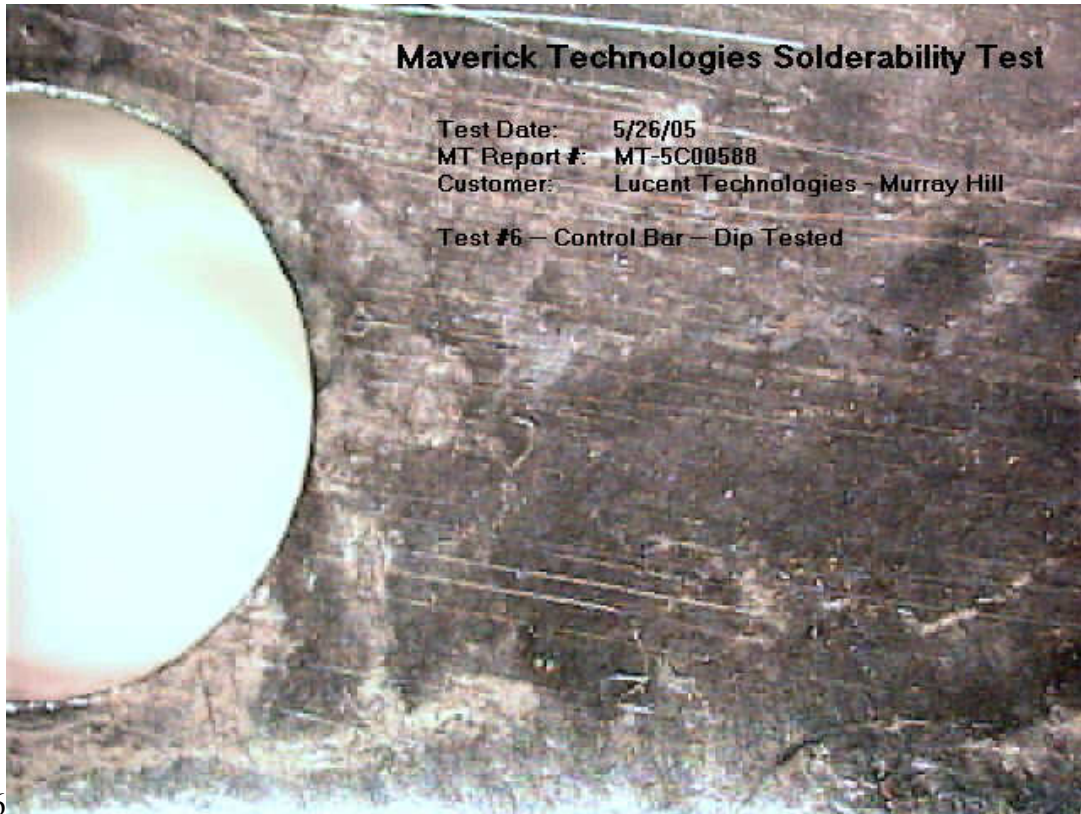
Sample 6

Samples 1-7 were each tested in the same manner and same conditions. Sample 6, the control exhibited 100% wetting and coverage over the entire bar. No non-wetted areas were observed. The photo of that is below. Again, light levels do not properly show the complete 100% coverage, but excellent solderability was observed on this sample.

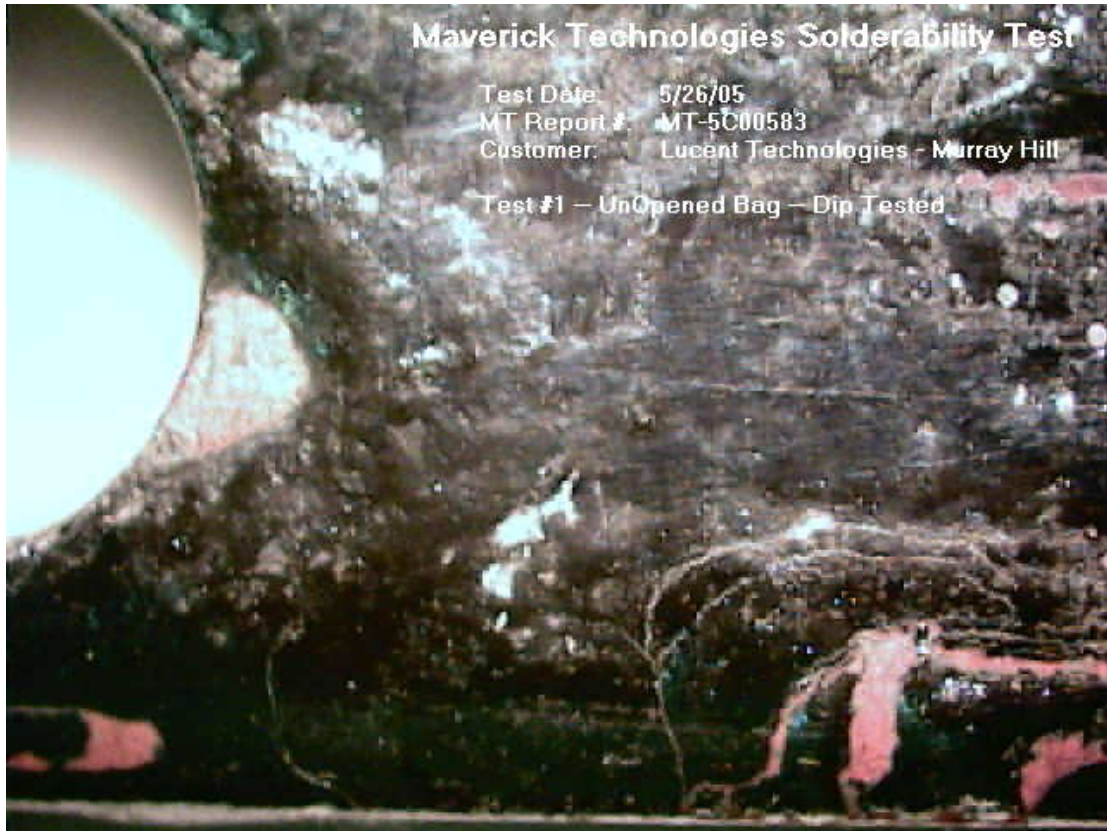
Sample 1

Samples 1-5 & 7 all exhibited the same level solderability, ~ 5% of surface area shown non-wetting conditions. Those pics are shown below.

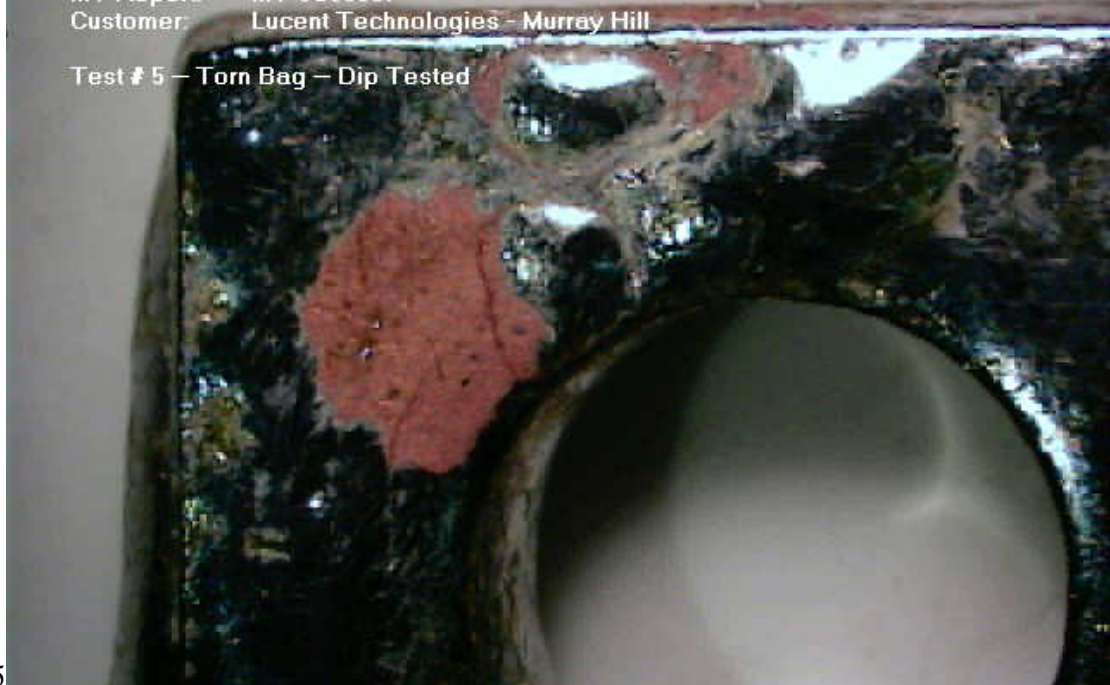
Sample 5

Test # 5 - Torn Bag - Dip Tested

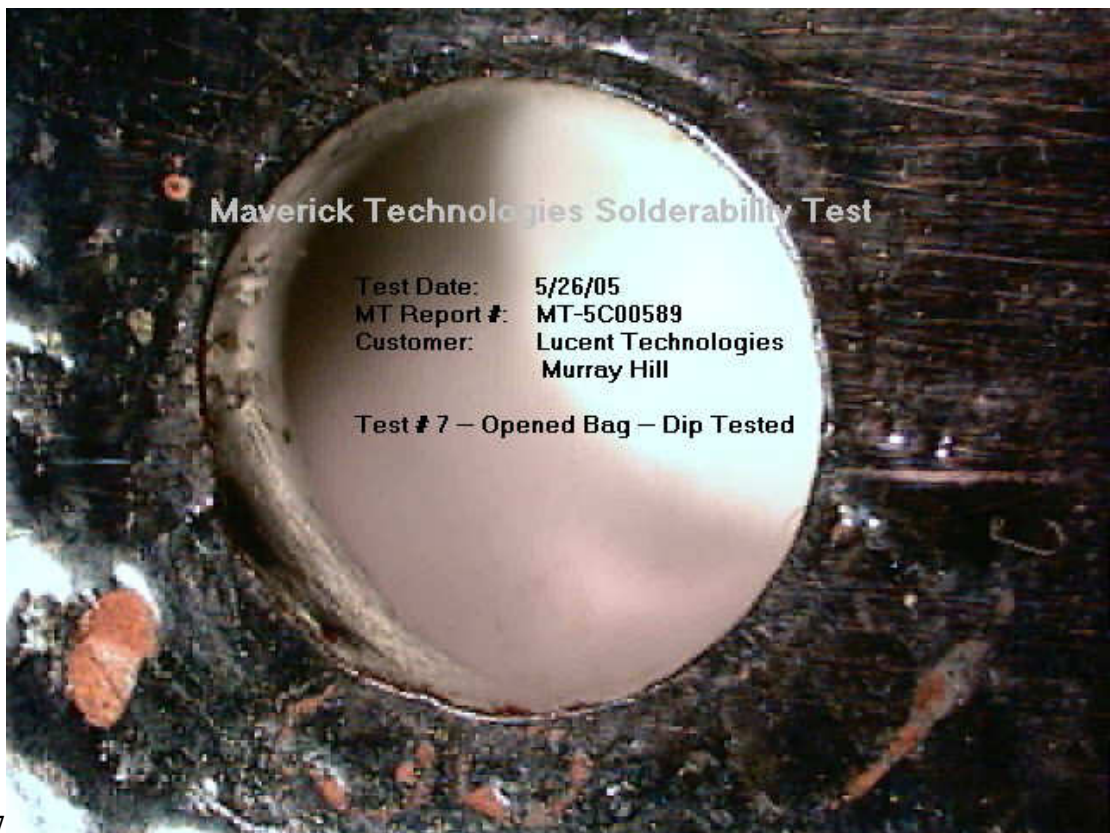
Sample 7

Test # 7 - Opened Bag - Dip Tested

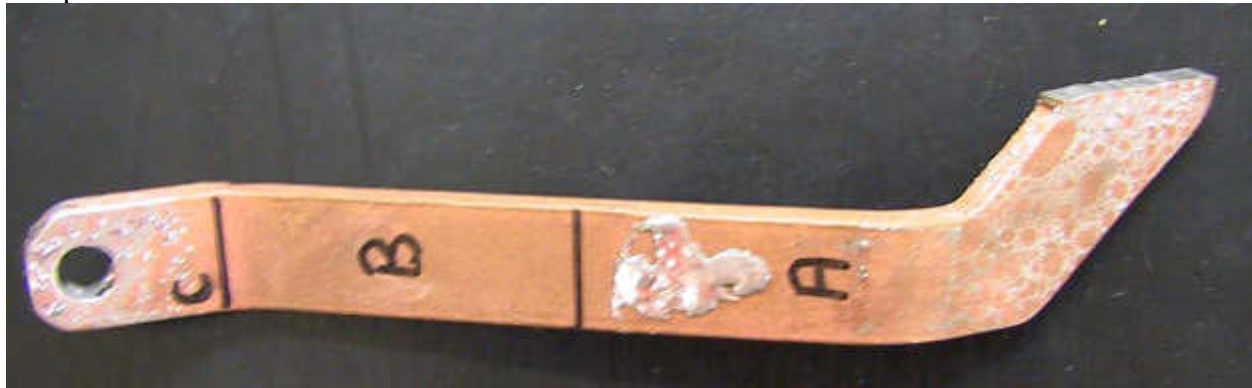
Sample 8

Sample 8, was tested slightly different. As shown below, 3 areas were marked off.

Area A, is was solder tested as received. Almost 100% non-wetting condition. Non-solderable surface.

Area B, was the as received area, with no tests performed.

Area C, was acid etched prior to solder testing, similar to Sample 6. A slight improvement, but the heavy layer of oxidation was not fully removed with the light acid etching. Still a Non-solderable surface.
